**AMMANA MARKET RENOVATION
MAJJASIM, IRAQ**

SUSTAINMENT ASSESSMENT

**SIGIR PA-09-171
JULY 30, 2009**

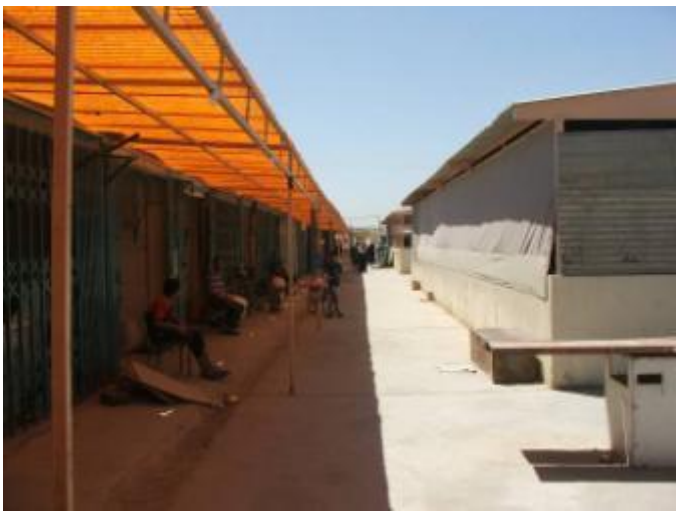
The concrete pad was constructed with expansion joints along the edges of the existing shops (Site Photo 2) and in the parking area (Site Photo 3); however, it was not apparent whether expansion joints were constructed in the slab beneath the steel truss roofs of the market stalls. Also, the contractor did not maintain the site: a bicycle had been ridden through the wet concrete.

Site Photo 2. Slab along existing shops

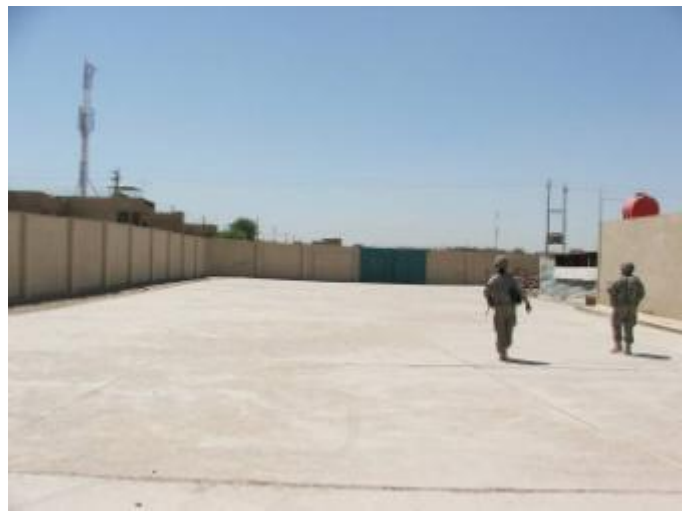
Site Photo 3. Slab at parking area

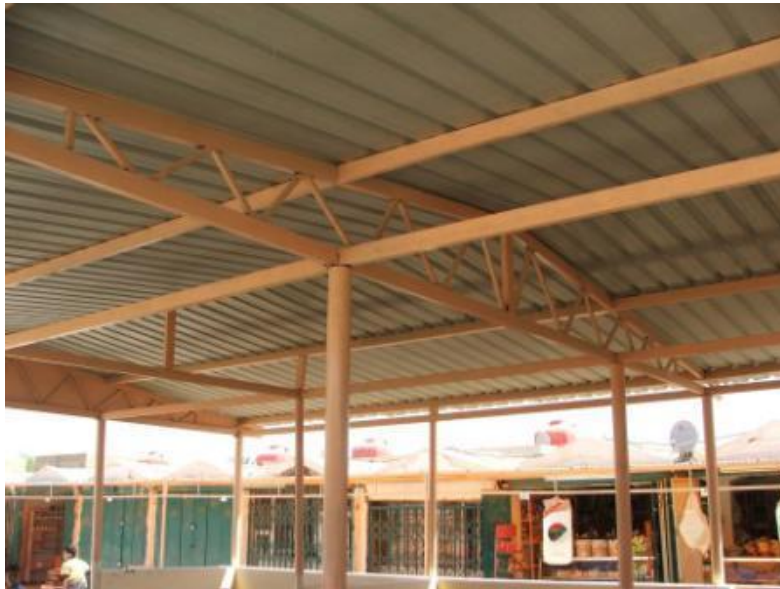
SIGIR observed four steel awnings installed over the interior courtyard of the market (Site Photo 4). The roof structure consists of steel pipe columns supporting steel trusses. The columns were cast into the concrete slab; therefore, the size and configuration of the foundation system could not be verified.

Site Photo 4. Steel roof trusses and columns—typical underside

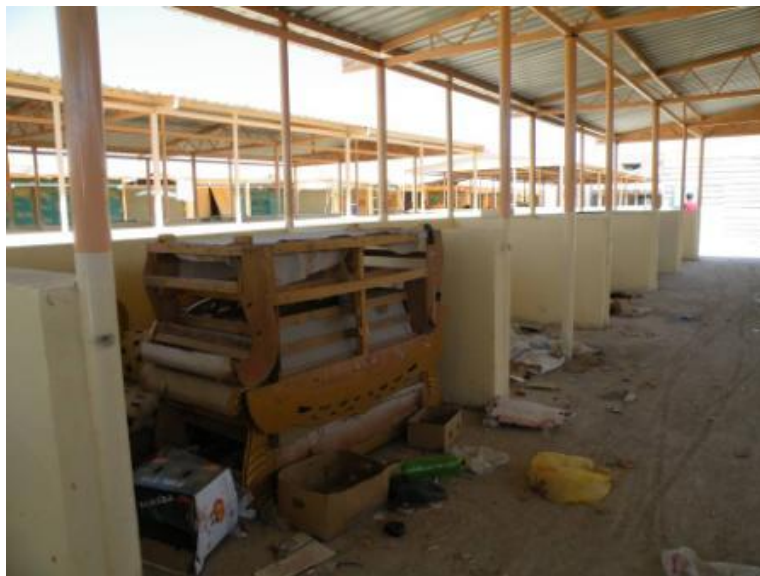
SIGIR observed a masonry infill approximately 1m high around the perimeter of the columns, with openings at either end. Also, masonry was constructed between the interior columns that divided the area into individual stalls with the main aisle in the center (Site Photo 5).

Site Photo 5. Masonry stalls with center aisle

The market manager stated that the interior stalls were used when large crowds came to the market and for vendors with no permanent venue at that market. SIGIR noted that the interior stalls did not appear to be used and were filled with refuse (Site Photo 5).

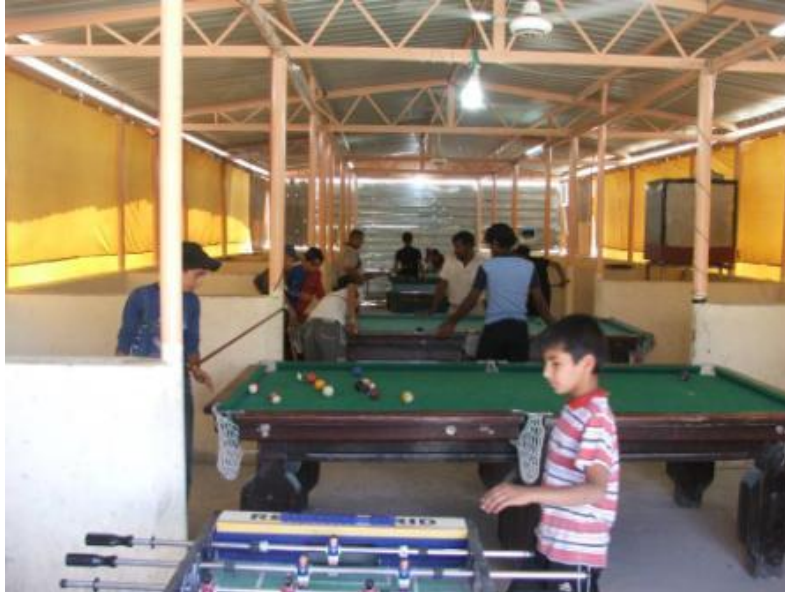
Under the awnings, one section of interior stalls was enclosed with tarpaulins, corrugated metal, and assorted construction materials and made into a makeshift game room. Evaporative coolers were installed at several points around the perimeter of the game room. The local citizens provided billiards, foosball, and other games for local children to play while their parents shopped at the market (Site Photo 6).

Site Photo 6. Modified interior stalls made into a game room

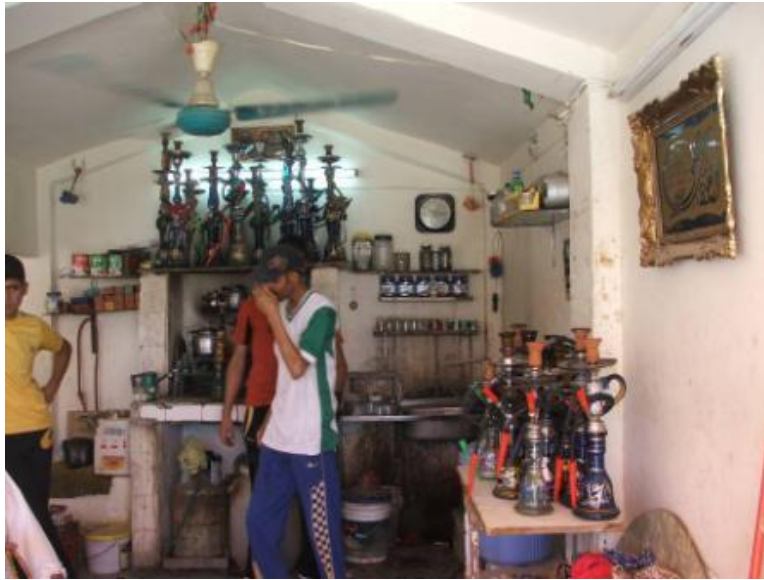
Because of time constraints, SIGIR was unable to inspect every shop; however, SIGIR inspected several representative shops. SIGIR observed that the contractor painted the interior and exterior of the shops (Site Photo 7). However, SIGIR was unable to determine if three coats of paint were applied or if the appropriate coating thicknesses was obtained.

Site Photo 7. Typical shop interior

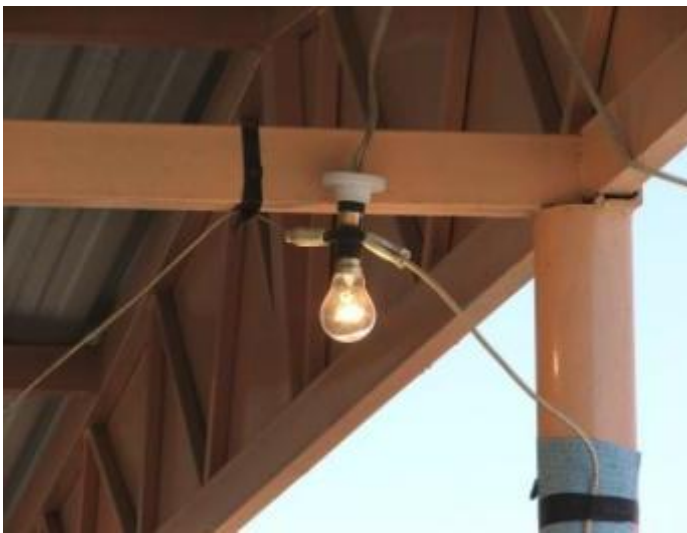
The construction of the internal electrical system was poor and did not conform to any known code. Light fixtures were affixed to the structure with bailing wire (Site Photo 8) or improvised wooden mounts and connected to the electrical system with temporary connectors (Site Photo 9). SIGIR observed that the electrical wiring was strung along the roof without conduit (Site Photo 10), and the electrical wiring appeared to be connected to a poorly constructed existing system (Site Photo 11).

Site Photo 8. Light affixed with bailing wire

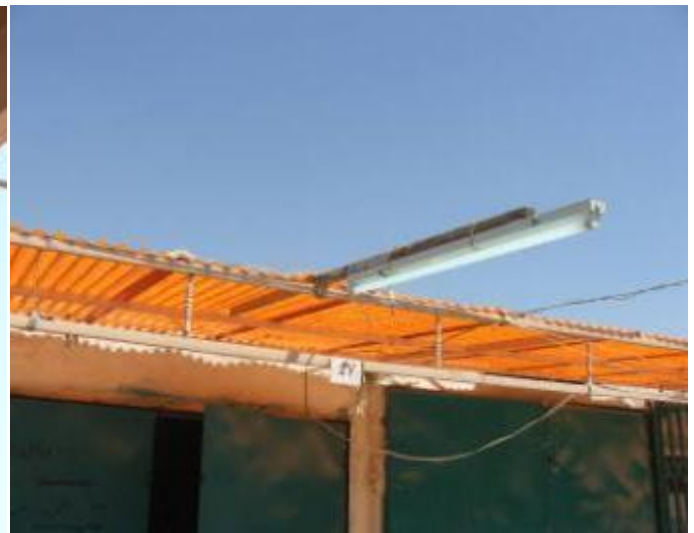
Site Photo 9. Light fixture with wooden mount

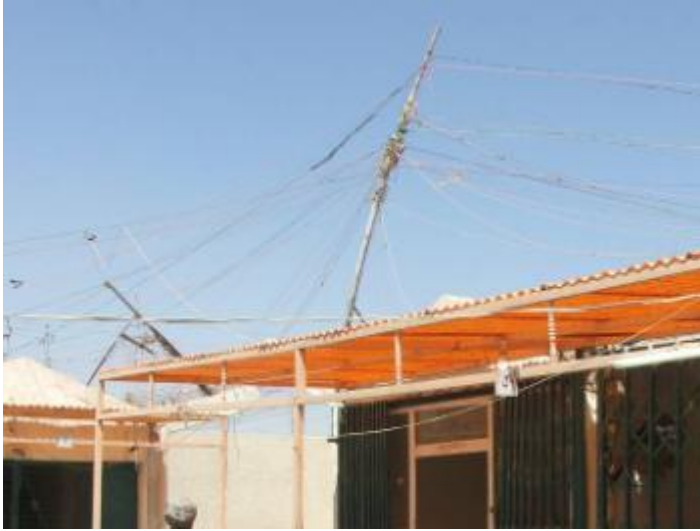
Site Photo 10. Electrical wiring without conduit

The standards and codes section of the contract requires the contractor to take the actions specified with respect to the electrical system and the structural building strength of the steel awnings in recommendations 1.c., 1.d., and 1.e. In view of the electrocution injuries and deaths occurring in U.S. constructed facilities in Iraq; SIGIR believes compliance with electrical code requirements—including enclosure of electrical wiring in conduit

and proper, secure mounting of electrical fixtures—is particularly important. SIGIR requests that MNC-I review page 13 of the contract and restate its position with respect to recommendations 1.c., 1.d., and 1.e.

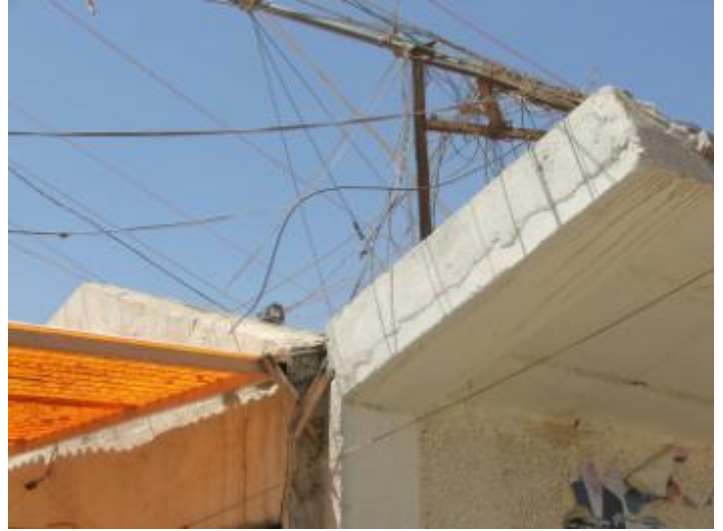
Site Photo 11. Electrical wiring connecting to system

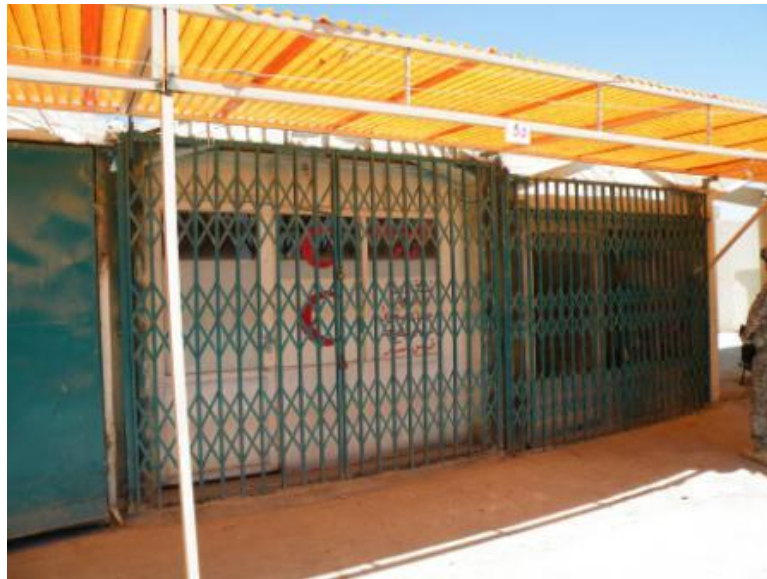
The individual market shops had either solid steel doors or folding metal grills for security (Site Photo 12). The quality of the doors appeared to be typical of locally available materials. Several doors inspected had padlocks as required in the SOW.

Site Photo 12. Security doors and grills

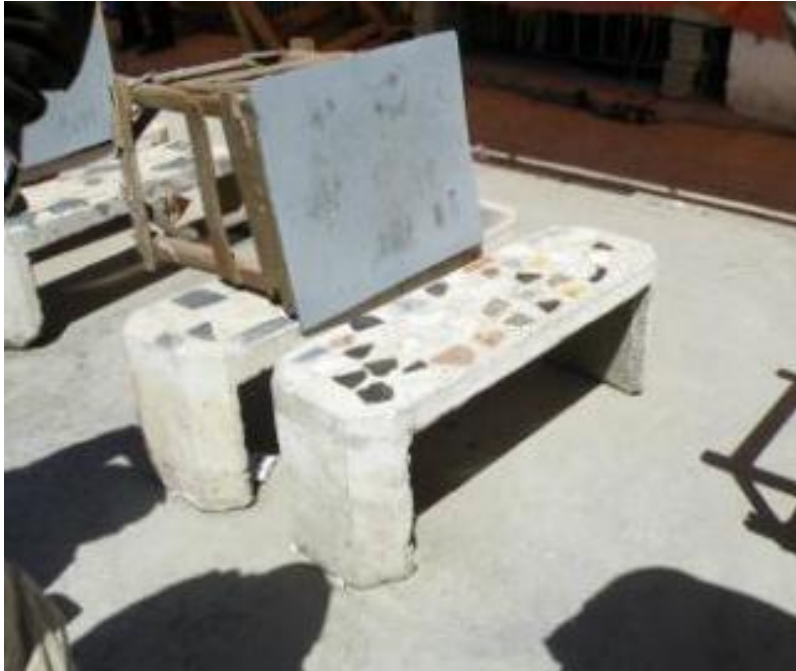
The SOW required the contractor to provide six pre-cast concrete benches for the project; however, the project file documentation lacked design information. SIGIR verified the presence of six pre-cast concrete benches on the project (Site Photo 13), which appeared to be of poor quality.

Site Photo 13. Pre-cast concrete benches

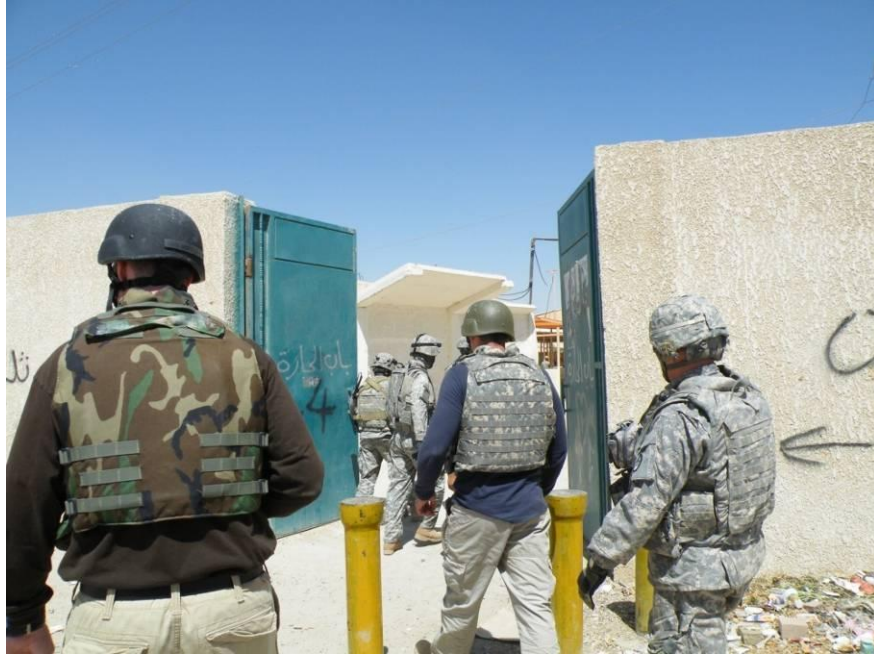
The security wall appeared to be constructed to the general overall dimensions indicated on the plans and in the SOW. The security wall had pillars installed at regular intervals. The construction appeared to be of decent quality, with no apparent cracking or settling of the wall (Site Photo 14).

The SOW required the contractor to install brackets and four strands of barbed wire along the top of the security wall. SIGIR observed that the security wall did not have brackets or barbed wire.

The contractor installed the pedestrian and vehicle gates in the perimeter security fence. The pedestrian entrances required bollards (safety guards) on their exterior to prevent vehicles from being driven directly into the market area. SIGIR noted that the bollards were constructed in the same general configuration as indicated on the plans (Site Photo 14).

The pedestrian and vehicular gates were constructed with a locking mechanism as required in the SOW, and the gates were generally the same height as the security fence. The SOW required the vehicular and pedestrian gates to be topped with four strands of barbed wire, similar to the specifications for the security wall. SIGIR noted that the pedestrian and vehicular gates were not topped with any barbed wire.

Site Photo 14. Bollards and pedestrian gate

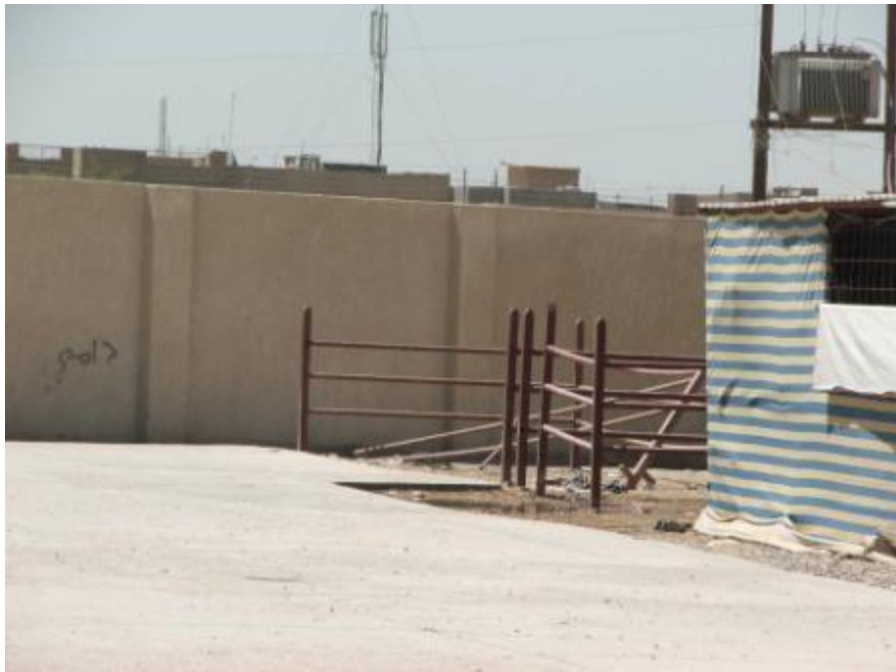
The SOW required the contractor to construct six animal corrals. Because of time limitations, SIGIR was unable to physically inspect the corrals; however, SIGIR did verify the existence of some of the corrals (Site Photo 15).

Site Photo 15. Animal corrals

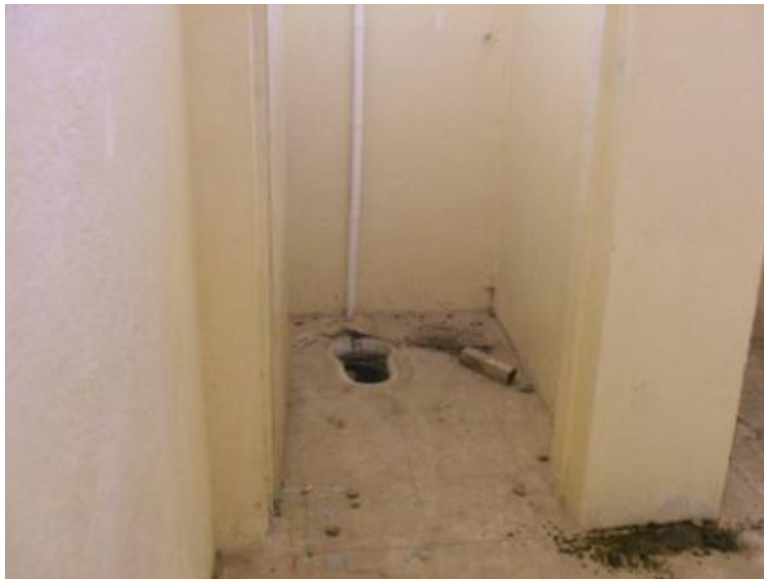
SIGIR observed the construction of two restrooms—one designated for males and one for females. The restrooms included typical eastern-style toilets in individual stalls with ventilation windows and steel doors (Site Photo 16). Lavatories were provided in the restrooms.

At the time of SIGIR's site visit, there was no water service to the restrooms. According to the market manager, the contractor connected the restrooms to the existing municipal water supply line. However, the contractor later disconnected the municipal water supply line to the restrooms. The market manager claimed that the contractor was trying to extort money from the shop owners to restore water service to the restrooms. SIGIR performed the inspections that it could in the time available and could not validate the assertion that the contractor had disconnected the municipal water supply line to the restrooms. The municipal water line was underground and there was no apparent disturbance of the ground around the Ammana Market.

Site Photo 16. Restroom stall

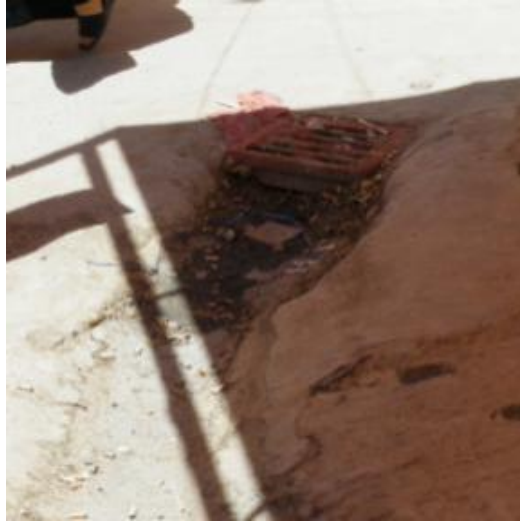
During the site visit, SIGIR identified drainage gutters in the concrete slab around the perimeter of the market courtyard. The drainage gutters consisted of a V-channel slope and allowed drainage to flow to the cast iron inlet grate (Site Photo 17). Because of time constraints, SIGIR was unable to determine whether the inlets were connected to a larger drainage system.

Site Photo 17. Gutter inlet

The drainage gutters were not covered with a perforated cover as required in the SOW. However, the use of perforated covers could be problematic. Perforated covers on the drainage channels would likely become clogged with debris, reduce their effectiveness, and require continual maintenance.
